Discussion

Determining the locus of failure in multilayer laminates is often the first step in understanding the cause of failure. In many cases a fraction of a monolayer of contamination is enough to weaken a bond to the point of failure. In this example we examine mating faces from a failed Cu-laminate (see schematic below). X-ray photoelectron spectroscopy (XPS/ESCA) is used because of its surface sensitivity and ability to quantitatively identify not only the elements present but also determine their chemical or oxidation state.

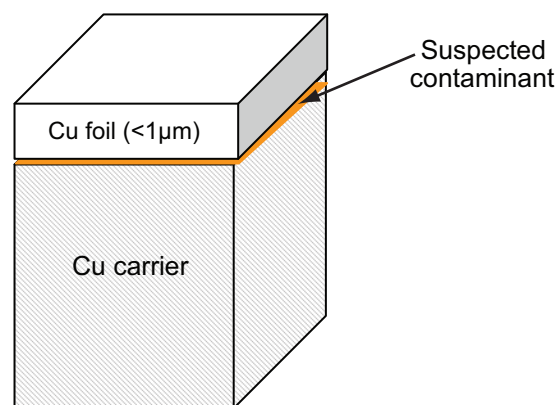
To probe the thickness of the Ni, Mo and P containing layers, the surfaces were depth profiled using a focused beam of argon ions. The resulting profiles reveal a roughly 10 Å phosphate layer on both sides of the failed interface. The P concentration is relatively low (2.5%); however, it is determined to be present as PO₄³⁻, meaning the total amount of phosphate at the interface is >5X the P concentration. The cation associated with the phosphate is likely either Cu⁺, Mo^{x+} or possibly H⁺ (hydrogen is not detected by XPS). Beneath the phosphate layer on the Carrier side there is ~100Å Ni₂Mo layer. A small amount of Ni was detected on the mating foil surface.

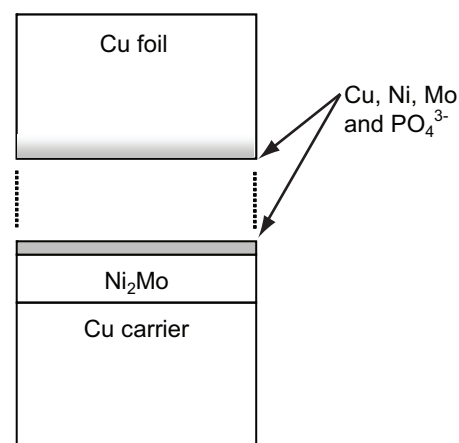
XPS was used to determine that adhesive failure occurred at a Ni₂Mo-Cu interface as a result of a high concentration of phosphate (see schematic in lower right).

Schematic of laminate structure and failure path based on XPS data
