Discussion

Determining the locus of failure in multilayer laminates is often the first step in understanding the cause of failure. In many cases a fraction of a monolayer of contamination is enough to weaken a bond to the point of failure. In this example we examine mating faces from a failed Cu-laminate (see schematic below). X-ray photoelectron spectroscopy (XPS/ESCA) is used because of its surface sensitivity and ability to quantitatively identify not only the elements present but also determine their chemical or oxidation state.

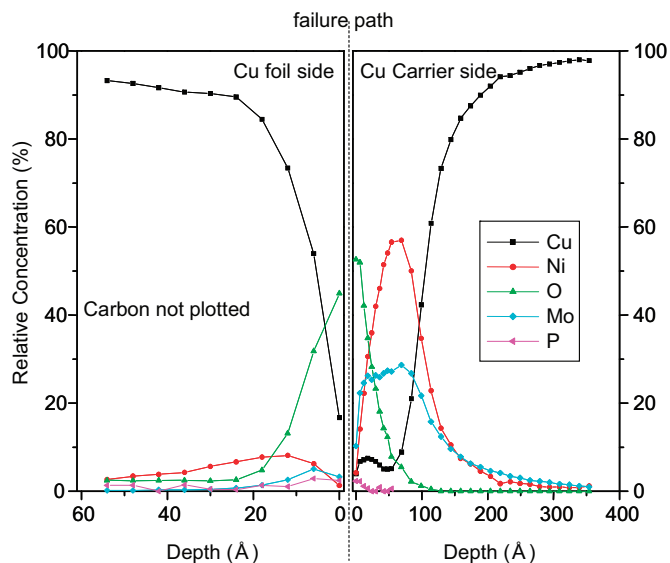
To probe the thickness of the Ni, Mo and P containing layers, the surfaces were depth profiled using a focused beam of argon ions. The resulting profiles reveal a roughly 10 Å phosphate layer on both sides of the failed interface. The P concentration is relatively low (2.5%); however, it is determined to be present as PO₄³⁻, meaning the total amount of phosphate at the interface is >5X the P concentration. The cation associated with the phosphate is likely either Cu⁺, Mo^{x+} or possibly H⁺ (hydrogen is not detected by XPS). Beneath the phosphate layer on the Carrier side there is ~100Å Ni₂Mo layer. A small amount of Ni was detected on the mating foil surface.

XPS was used to determine that adhesive failure occurred at a Ni₂Mo-Cu interface as a result of a high concentration of phosphate (see schematic in lower right).

Schematic of laminate structure and failure path based on XPS data
